Study and Analysis of Innovative Financing for Sustainable Forest Management in the Southwest Balkan

Cross Cutting Issues and Summary of the Ulza Watershed Case

Date prepared: October 2014

This report provides the summary and cross cutting issues from the Ulza Watershed Case of this study. It presents the overall results of the influence of forests and other land uses on erosion and sedimentation. It also provides the results of comparative analyses between the two phases of the study, 2011 through 2014. All results are based on the underlying technical documents for the Erosion Case, presented in detail within this study.

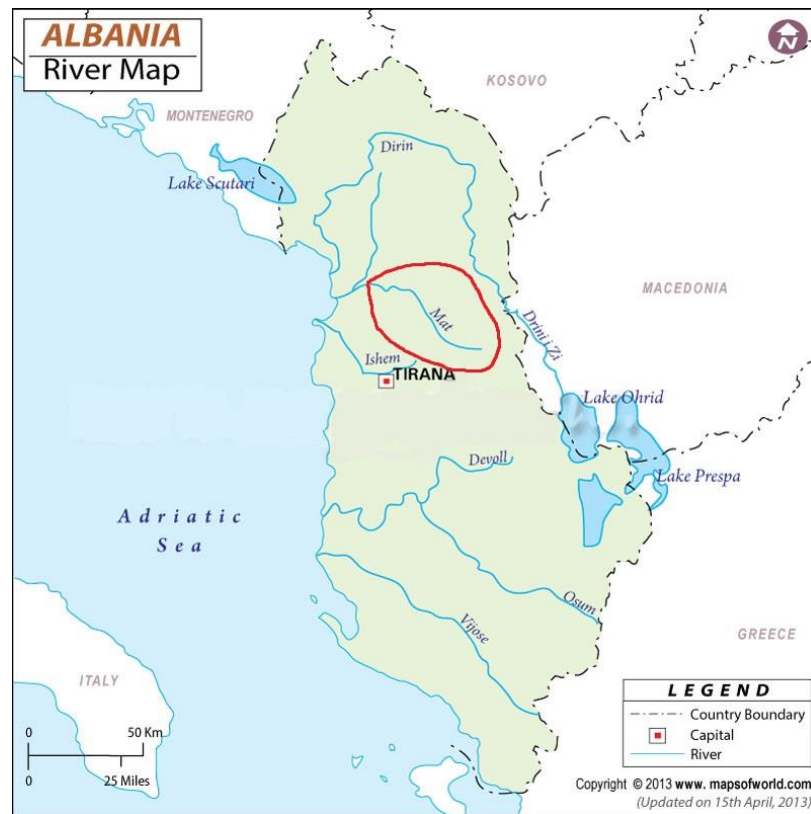
Figure 2: Mati River and Study area

The Ulza watershed is located in (and is a sub-watershed of) the Mati river basin about 70 km from Tirana, covering almost the entire Mati district of the Diber region (refer figure 2). The main towns in the watershed are Burrel and Klos, while the watershed further comprises 13 Communes (2 of which are partially located in the watershed).

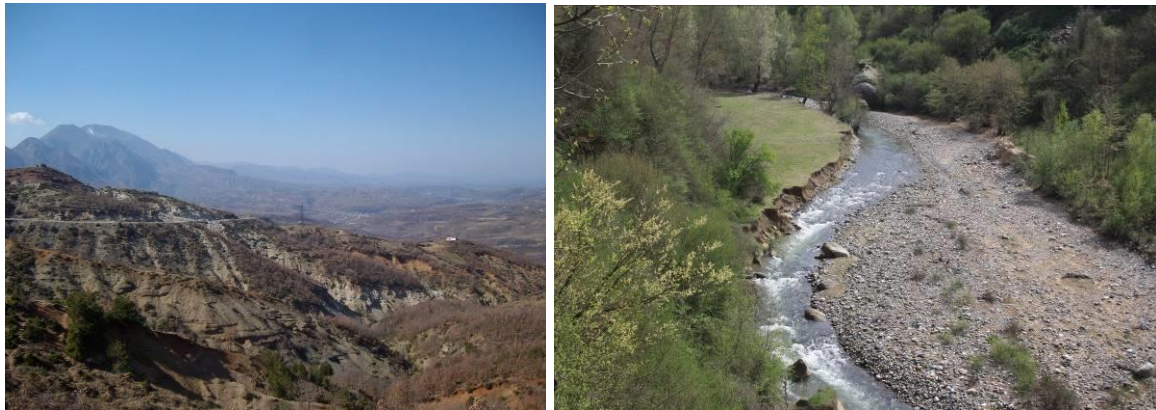
Erosion is a widespread phenomenon in Albania and is a cause for many problems leading to land degradation on the eroded sites, but also causes downstream problems due to siltation, sedimentation and flooding. The Ulza watershed is a typical example in Albania of an area with high to extremely high erosion (figure 4). This is causing direct land degradation, but in the Ulza case also leads to high sedimentation of the Ulza reservoir with a negative impact on the UHPP. It also creates damages

Figure 4: Erosion in the Ulza Watershed

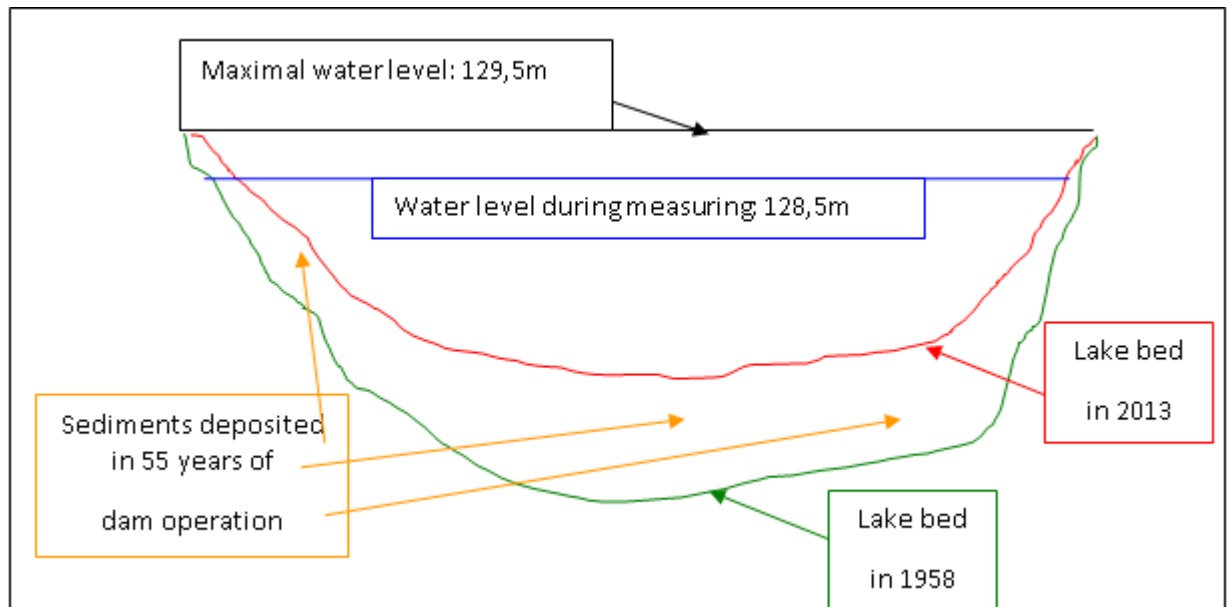
To understand the magnitude of erosion it is important to know the amount of sedimentation in the watershed. How much sedimentation is present in the lake? To what extent has the lake filled during its existence since 1958 (refer figure 6)?

Figure 6: Schematic view of sedimentation in the Ulza reservoir

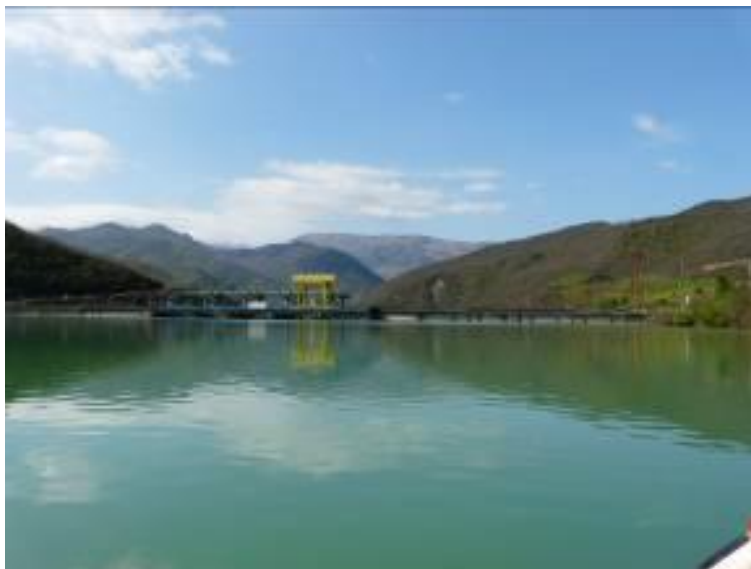
The reservoir and the dam are shown in the picture below.

Figure 7: The UHPP dam and its lake

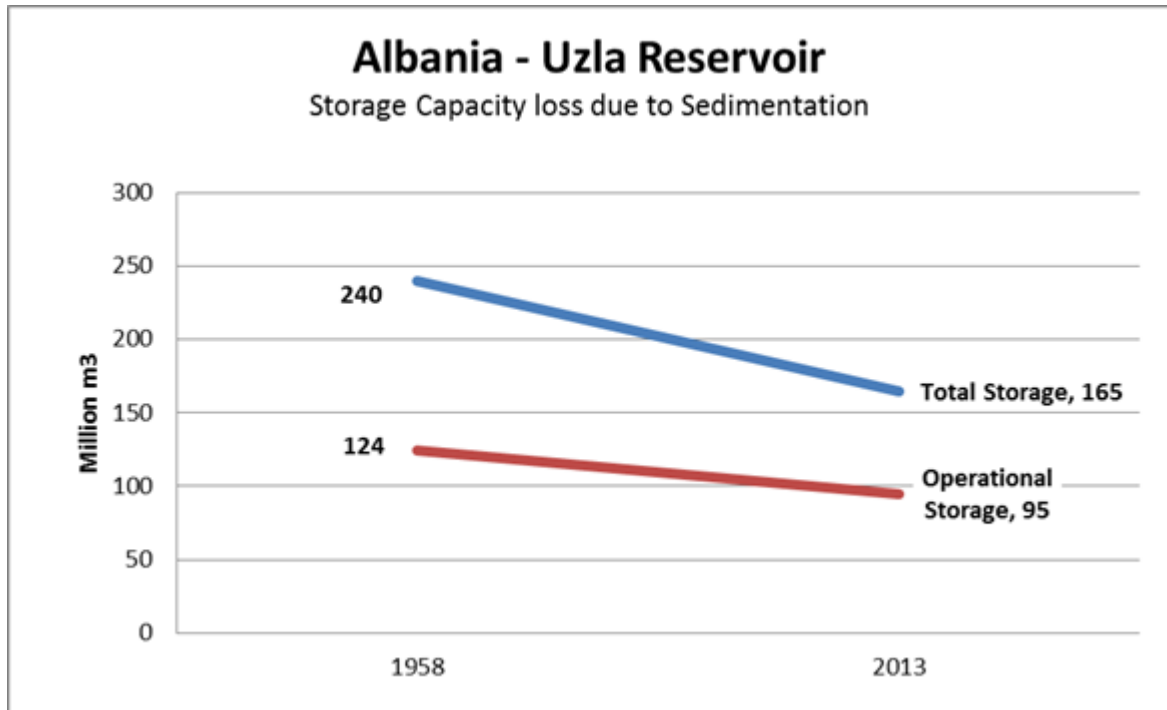
The 2013 bathymetry measurement showed significant sedimentation, with at least 31.5% of the total reservoir storage filled with sediment (figure 8). More importantly, sedimentation has reduced the operational capacity because 23.3% of the sedimentation is already in the "operational storage" of the reservoir, decreasing its volume and functioning (figure 8). Especially the reduction of the operation capacity is a concern since this has a direct economic effect on the UHPP. It increases the urgency to reduce erosion and sedimentation in the Ulza watershed.

Figure 8: Level of reduced operation and total storage of the Ulza reservoir

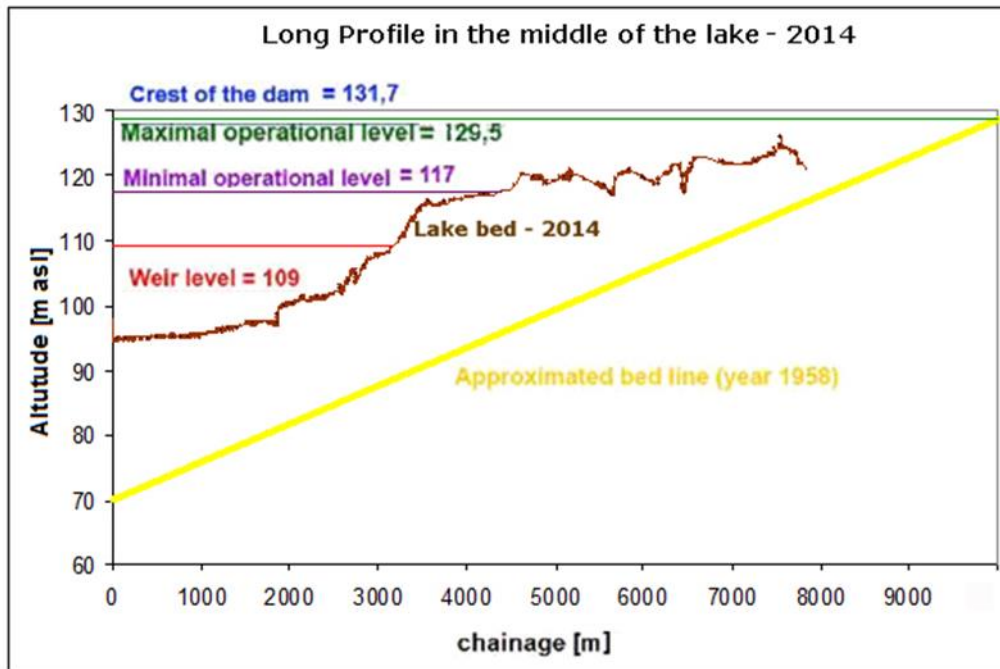
Significant sedimentation of the operational storage starts about 4 km upstream from the dam, while the larger part of the "dead storage" is already filled with sediment. The average annual quantity of deposited sediment (1,331,741 m³/year for the whole watershed and 1,113 m³/km²/year) is at least three times the average in the region. Future sediments will deposit additionally in the operational storage because a significant part of the non-operational storage has been filled (see figure below).⁷

Figure 9: Long profile in the middle of the lake

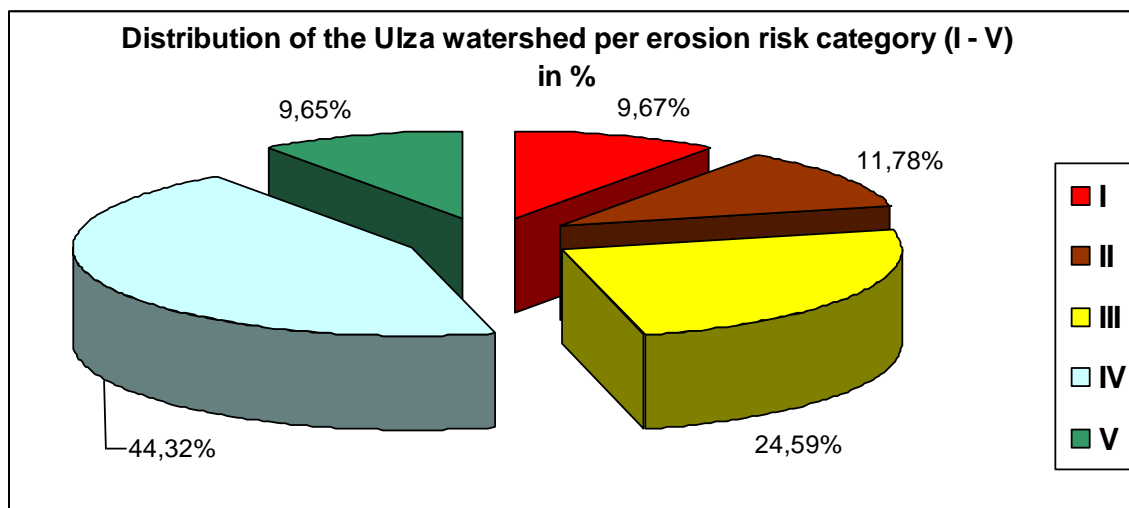
The highest erosion occurs on 9.67% of the category I and E area (117 km²), and is designated as territory where urgent erosion control works are necessary. Additionally, stronger erosion processes (II and III category) are spread on 36.35% or 440 km² (figure 12).

Figure 12: Distribution of the erosion risk category in percentage in Ulza watershed area

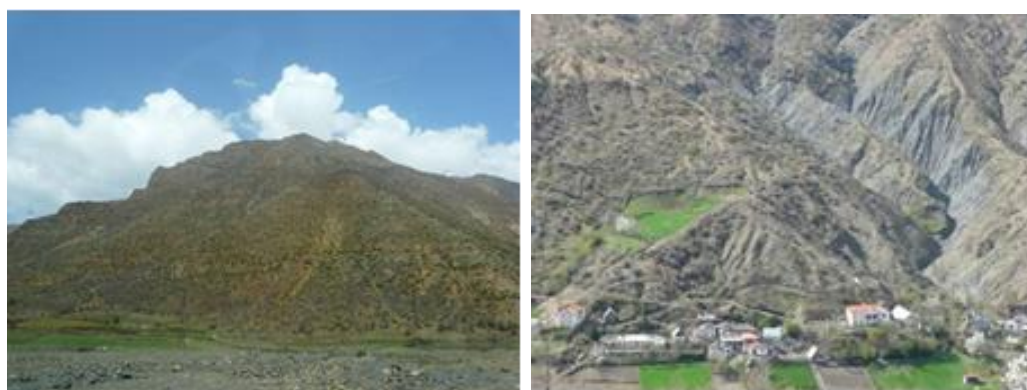
The erosion map is made using the land uses in the watershed and through on-field observation by assigning an erosion co-efficient to each area (see figure 13 for examples). The coefficient is a measure of erosion and is valuable in comparing areas on erosion levels and risks.

Figure 13: Examples of erosion (sheet and gully) classified with the erosion coefficient

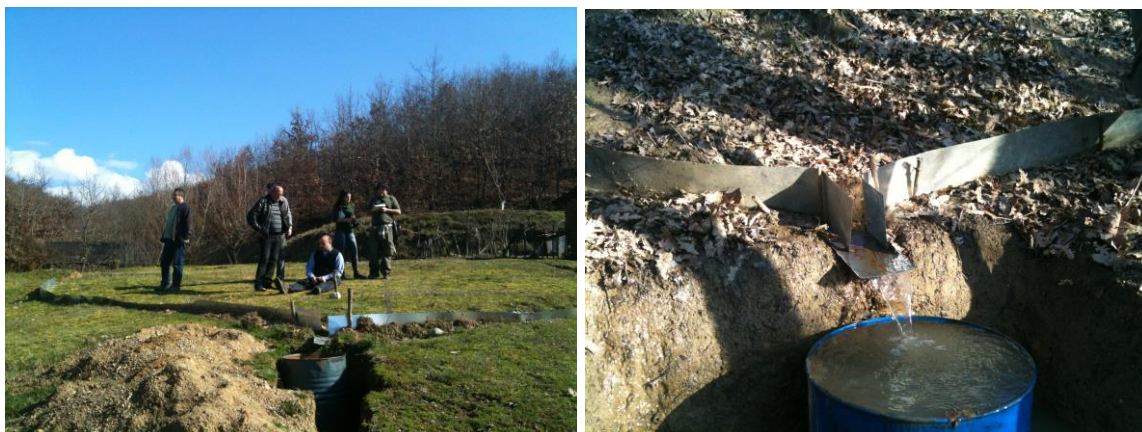
Figure 14: Erosion monitoring plots

Field monitoring for erosion and run-off for different land uses were made in the study (figure 14). It is possible to slow down the sedimentation in the hydropower reservoir by reducing erosion and run-off. The study gave insights into good practices and land uses on the correlation between precipitation, run-off and sedimentation in different land uses and slope categories. 48 erosion plots (figure 15) with different land uses and slope conditions were regularly measured in this study.¹¹ The first phase was from 1 October 2012 to 31 Aug 2014. The second phase was from March – August 2014.

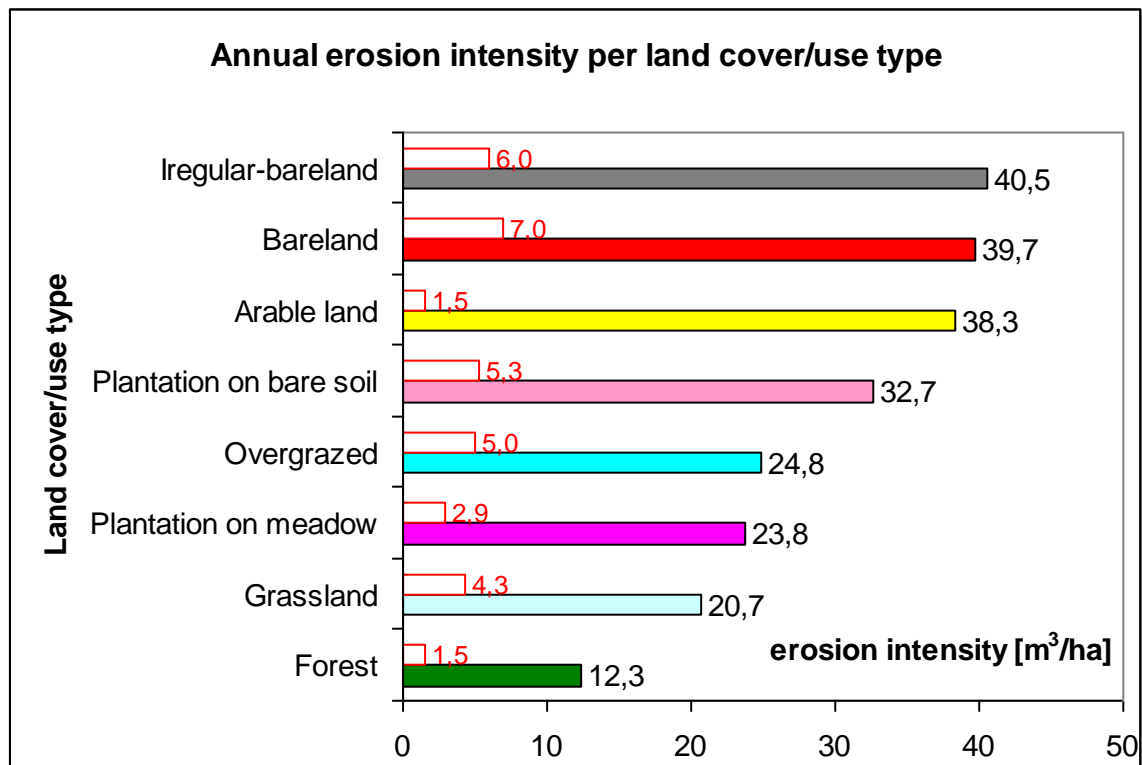
Based on the results from the first phase (2013) the study showed that erosion and sediment load are correlated to land uses. Land uses with the highest to the lowest erosion and sediment load are: Bare land/degraded area > Arable land > Young plantation on bare land > Overgrazed land > Plantation on meadow > Planation with non-grazed meadow > Forest (see the figure below). Bare land has 3 times higher sediment load than forests (figure 16).

Figure 16: Annual intensity of erosion (sediment production) per land use type and mean error

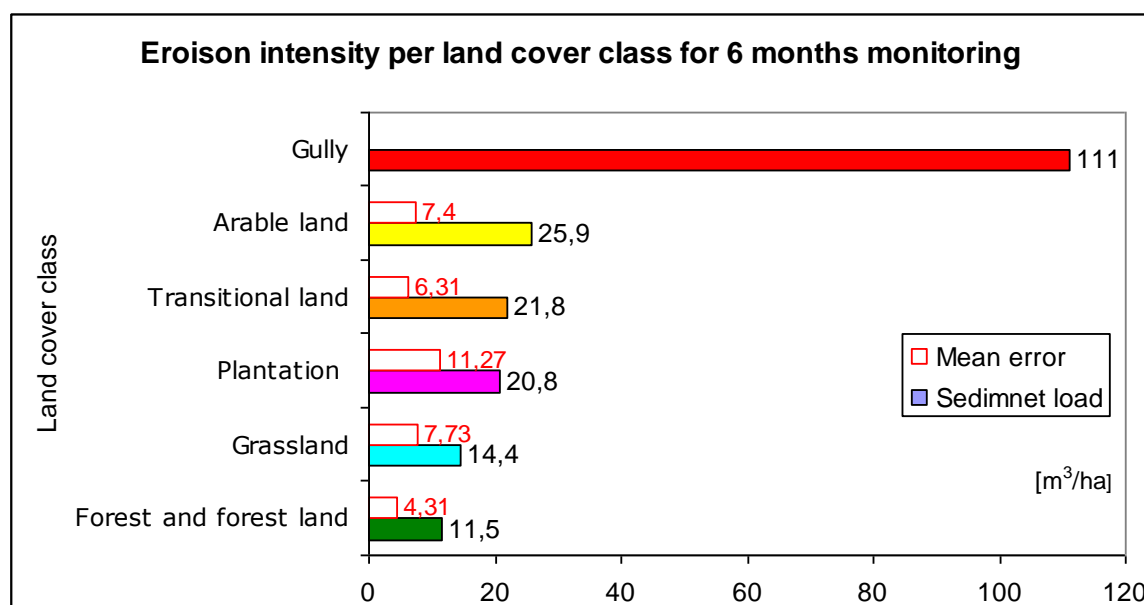
Gully erosion is limited as a land cover, but is very important on the total sediment production due to its severity. Understanding this emphasizes the importance of taking specific erosion control measures for gullies. The results of the 2014 monitoring confirm the high level of erosion production by gullies (see figure below).

Figure 17: Sediment load per land cover type and gully in m³/ha (during monitoring period)

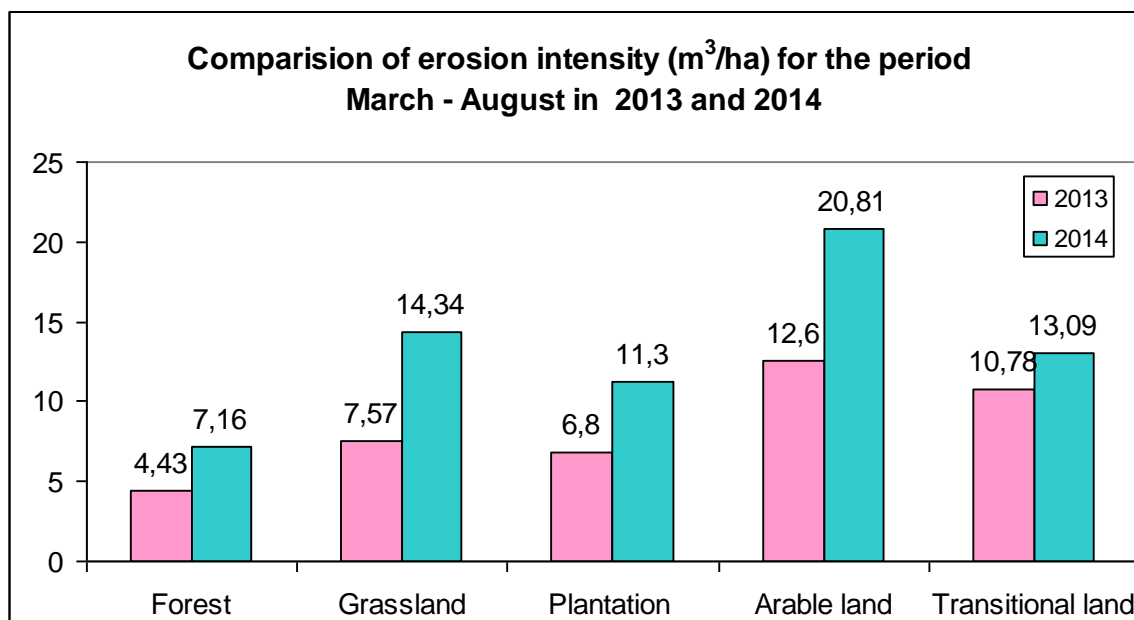
The sediment results from the 2014 monitoring show the influence of forest crown cover and ground cover. The transitional woodland plots with a low crown and ground cover show higher erosion levels compared to grassland and plantation with ground cover. Regular forests again provide the lowest sedimentation results.

Figure 18: Comparison of erosion intensity for the period March-August in 2013 and 2014, per land cover class [m³/ha]

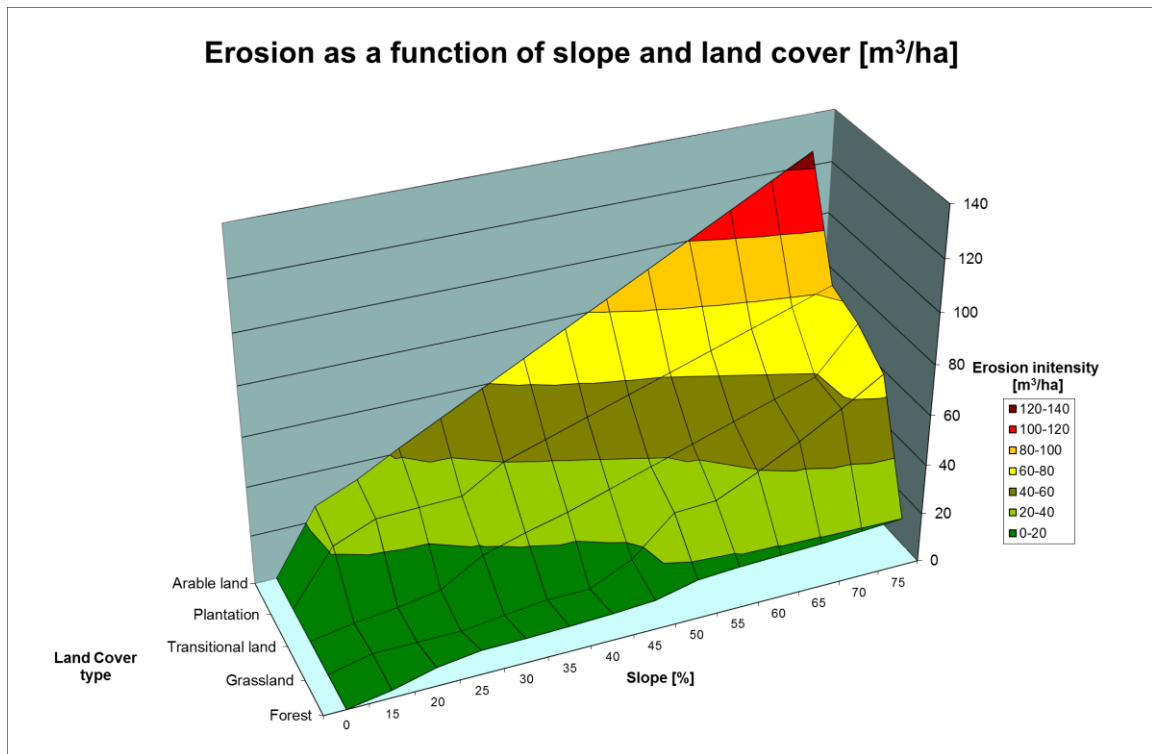
The relation between land use type, slope and erosion intensity is clearly visible in the diagram below. With an increased slope the erosion rate is increasing dramatically for arable land and plantation. On the other hand, slope has hardly any influence on forests.

Figure 19: Relation of land use type and slope on erosion intensity

It must be noted that the used data are based on the erosion monitoring during 2014. Therefore the absolute values of erosion intensity are an indication of erosion in that period, with an above average rainfall. The erosion intensity is very high and does not reflect an average value. It can be used as comparative data showing the relation between land use, slope and erosion intensity.

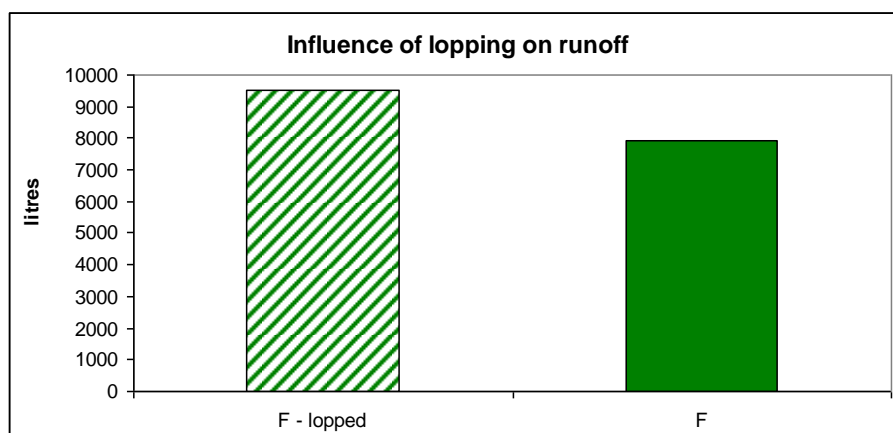
Figure 20: Influence of forest lopping on run off

As shown, the slope is not the main factor influencing erosion intensity of forests. Crown cover and forest structure are more important factors for erosion. The influence of crown cover is also visible when comparing the results between plots of forest with different crown covers and structure; regular forest (with a closed canopy) and forest plots with tree lopping and pruning (with an open structure). The influence of crown cover is limited regarding runoff (figure 20), but there is a high reduction of erosion with increased crown cover (figure 21).

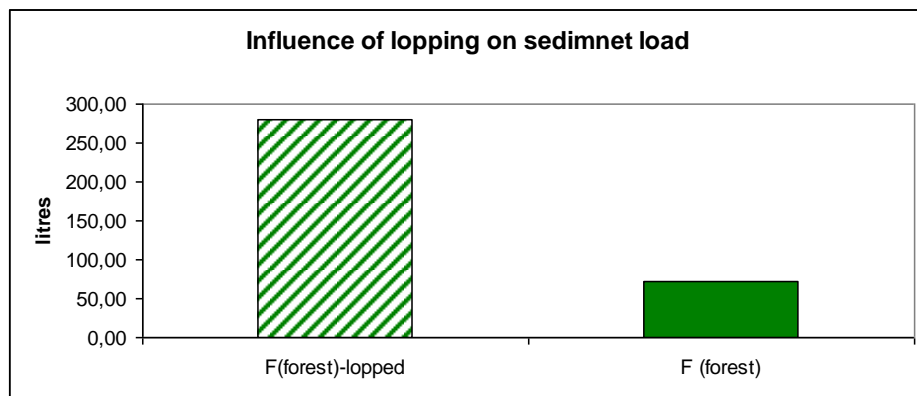
Figure 21: Influence of forest lopping on sediment load

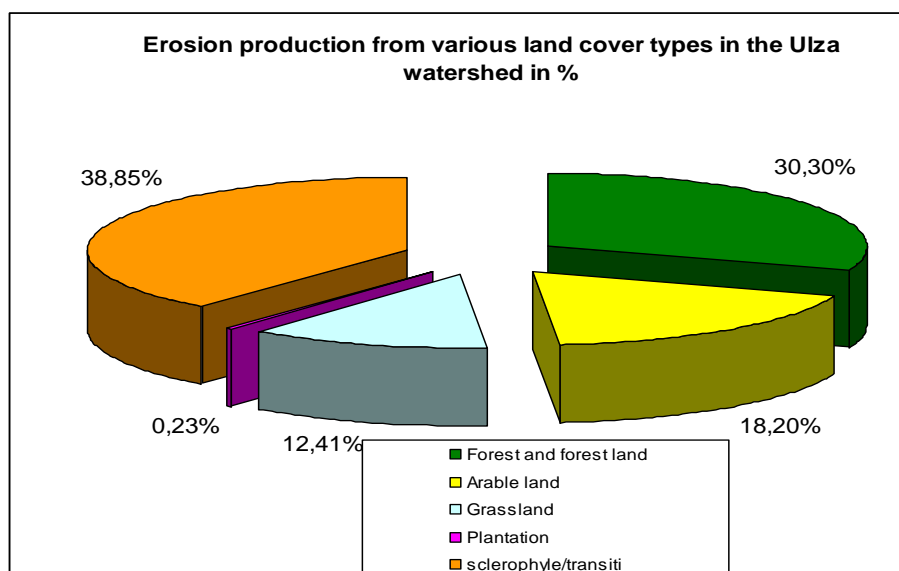
Figure 23: Erosion production from various land cover types in the Ulza Watershed

On the other side, even though arable land is only 11.5% and basically on lower slopes, it contributes with 18.2% of erosion production in the Ulza watershed. Another important figure is that transitional woodlands are significant part of the Ulza watershed with 29.3% of total surface. These lands are usually covered with degraded wood vegetation or shrubs where wood and shrubs cover is less than 50% and usually there is no grass cover on the site. Very often there are gullies appearing at the spot. These areas are usually on slopes higher than 30%. This land use type is producing the largest quantity of erosion in to Ulza watershed with 38.9% of total erosion intensity. The grasslands are basically providing proper protection from erosion as land use type.

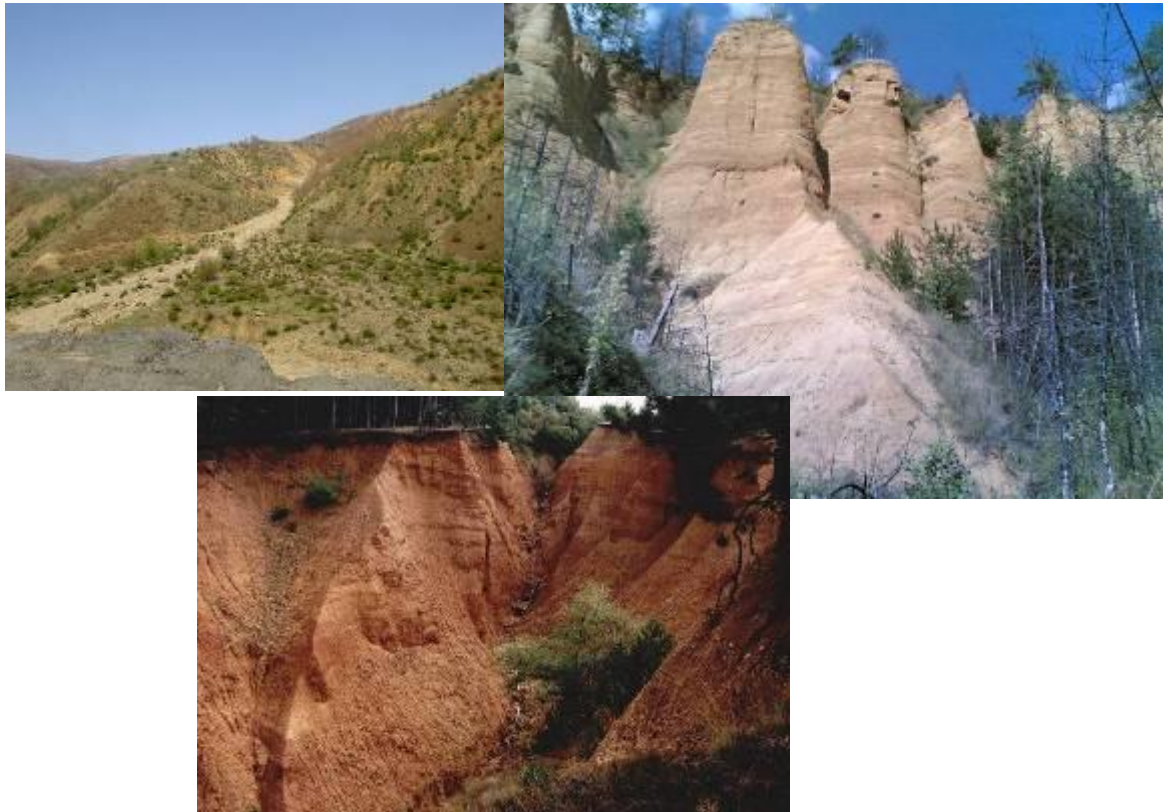
The Kalimanci reservoir basin is one of the most eroded areas in Macedonia. The reservoir basin is similar to Ulza 1,224 vs. 1,135 km². Erosion processes are similar (figure 24); the main difference is in their extent.

Figure 24: Extreme erosion process in Kalimanci basin

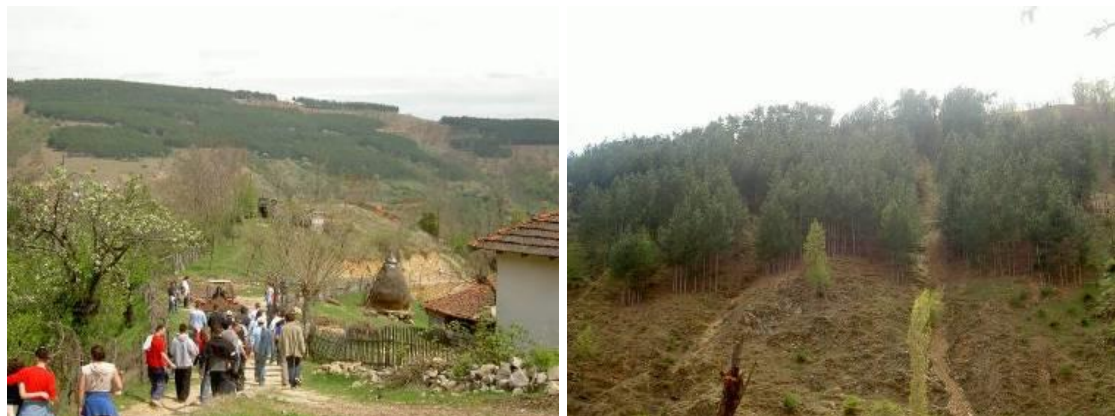
Figure 26: Afforested terrains

The soil is highly prone to erosion and in cases of a small open areas without forest cover gullies appear (see figure above right). Therefore forests are needed with a good structure and close crown canopy. There were a lot of construction works in the stream beds in addition to afforestation. These structures are made of wood, rocks, gabions, concrete and have different height and form. In Albania good practice and experience also exist (figure 27), which can be applied on high erosion risk areas such as in Ulza.

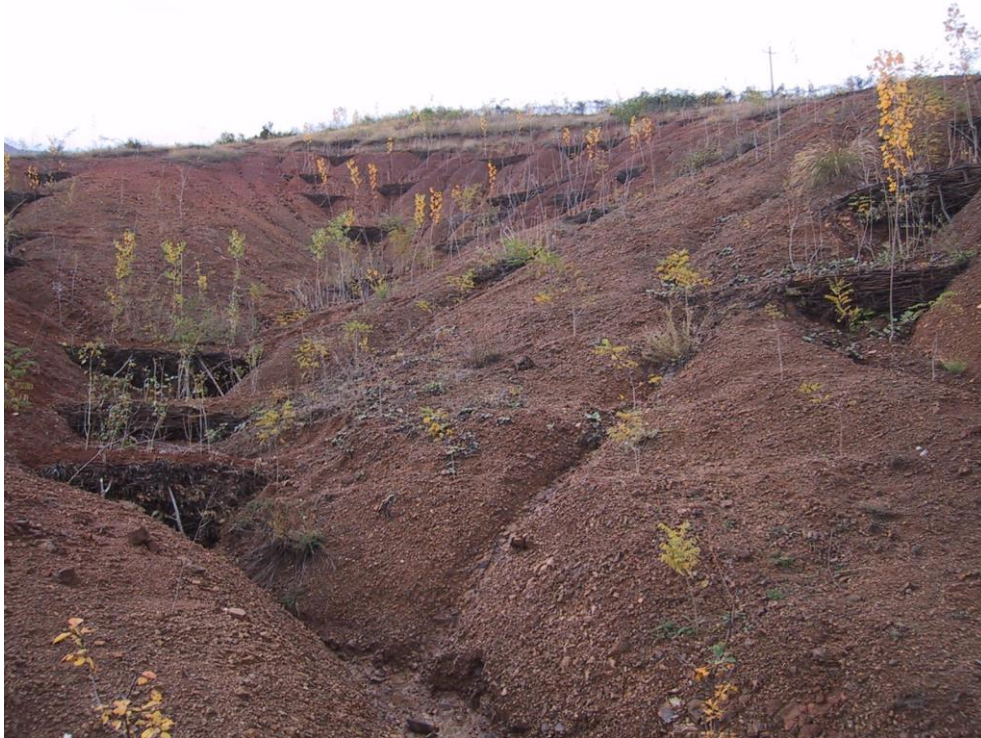
Figure 27: Application of double fence dams and plantation in Diber, Albania for erosion control

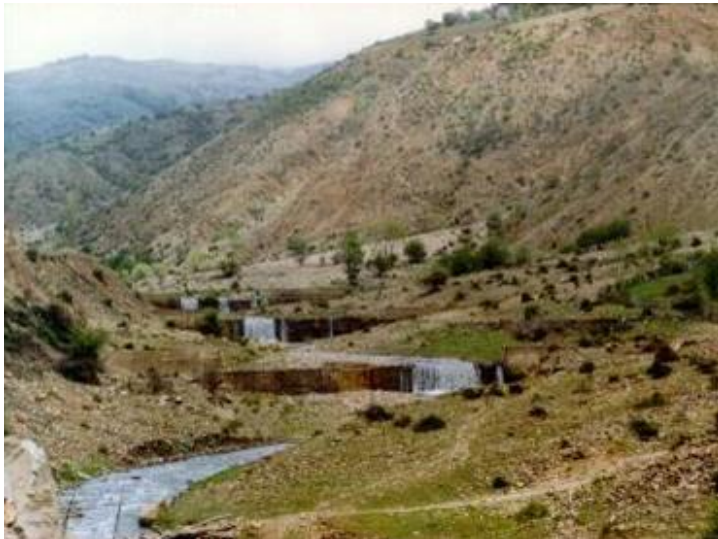
Check dams (see figure 28 and 29) were constructed in Kalimanci in the Kamenicka River to control the water flow, reducing the kinetic energy. A lot of torrents are regulated totally or partially due to these works in the Kamenicka River in the Kalimanci Watershed. These check dams retain significant quantity of already produced erosive material. Measurements in Kamenicka River show that at least 2 million m³ are retained behind 51 check dams.

Figure 28: Check dams in the Kamenicka river bed (system of check dams in the river bed)

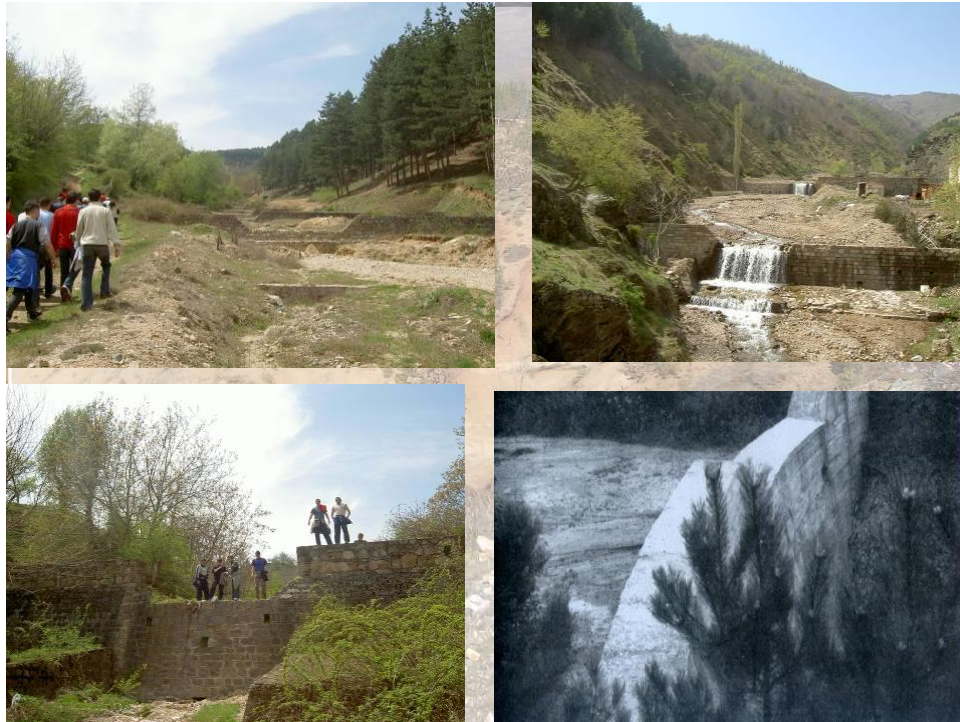
Figure 29: Various check dams in the tributaries of Kamenicka River

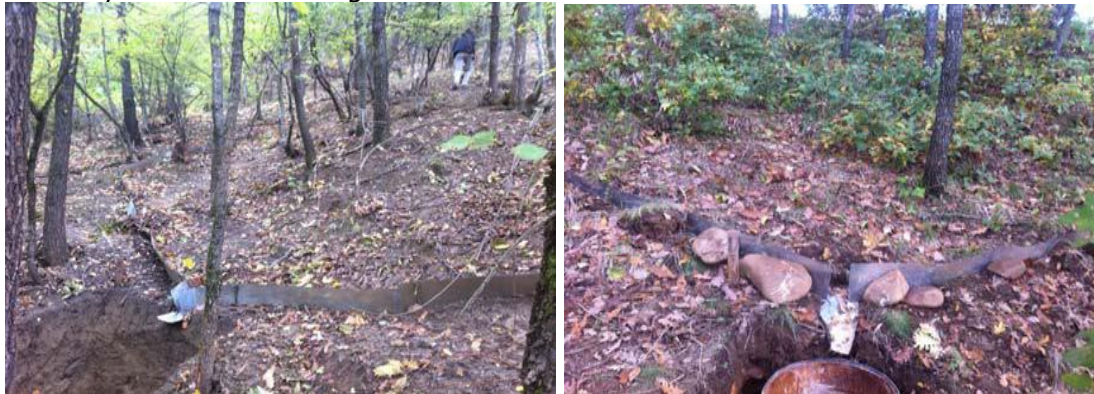
F – Forest - these plots represent Oak forest with relatively good ground cover. Within the basin there are some other forest types - beech forests and pine forests, but they are located at higher elevations.

Figure 30: Example of forest plot

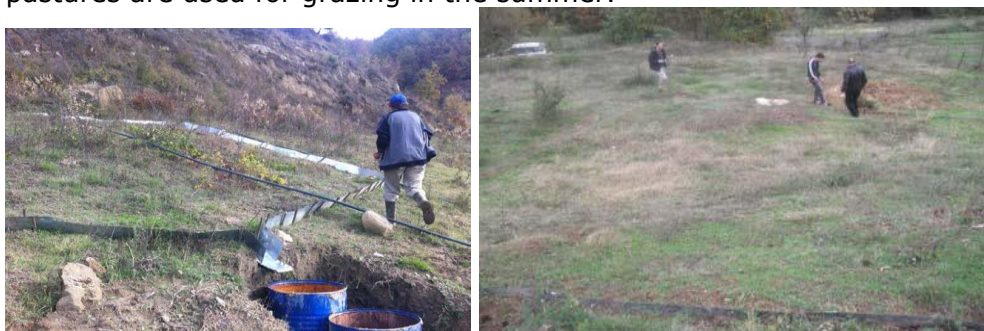
O – Overgrazed – grassland where grazing is allowed. This is the predominantly form of range land in the area. Most of the grazing is free grazing and herding with cows, sheep and goats. Grazing is whole year round at lower altitudes, while the high pastures are used for grazing in the summer.

Figure 32: Example of overgrazed grassland plot

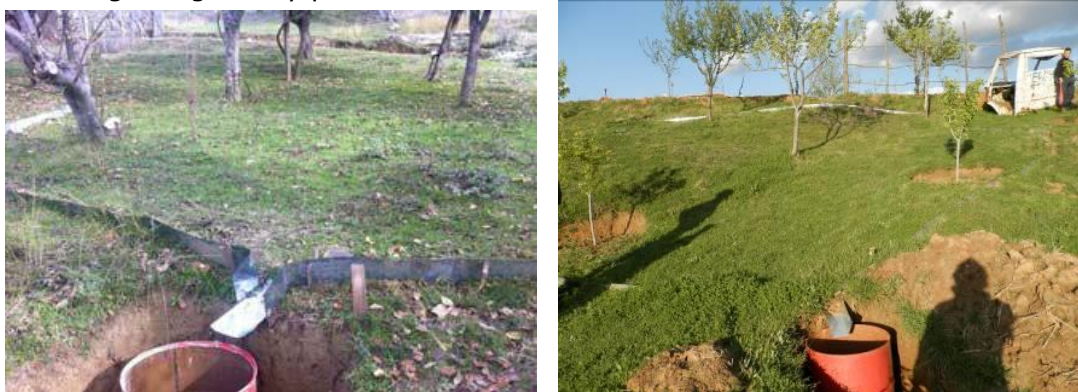
Pm – Plantation mature – Orchard plantation where there is green ground cover. In the Ulza watershed farmers are increasingly involved in horticulture with a variety of fruit trees. In general these land uses have a good ground cover with grassland use for grazing or hay production.

Figure 33: Example of mature plantation plot (plantation on meadow)

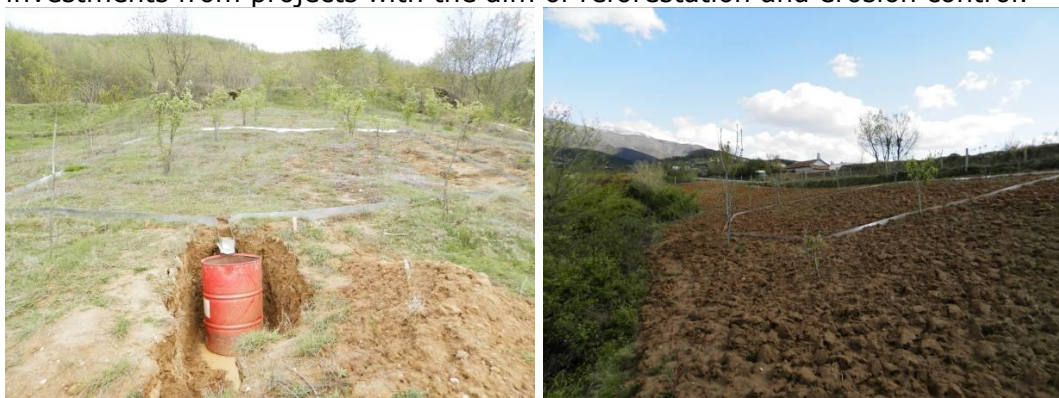
Py – Plantation young – Young 2-3 year plantation on former bare land (trees are almost unnoticeable). These are located in general plantations made with support of investments from projects with the aim of reforestation and erosion control.

Figure 34: Example of young plantation plot (on bare soil)

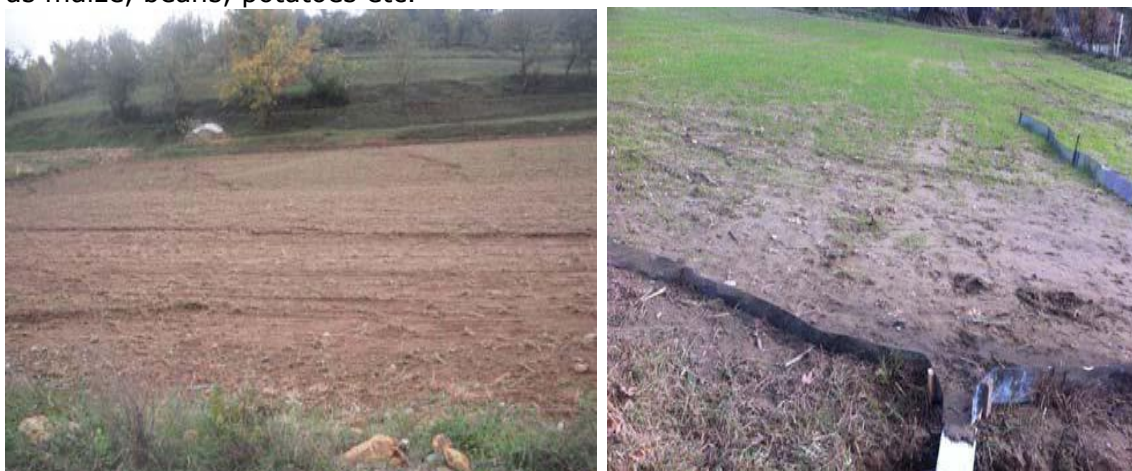
A – Arable land – classical arable land. Used for farming of agricultural crops such as maize, beans, potatoes etc.

Figure 35: Example of arable land plot

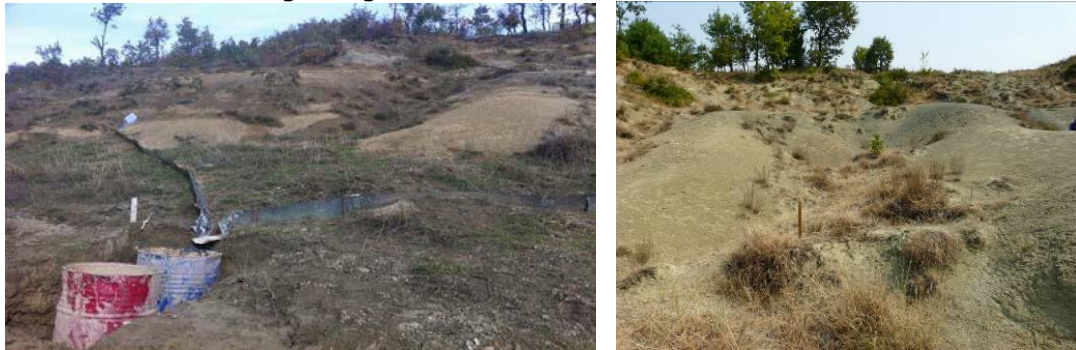
I-B – irregular shape plot/bare land – These are based in gullies with high erosion. Some having low ground cover, others transitional woodland cover.

Figure 36: Example of irregular shaped plots, bare land

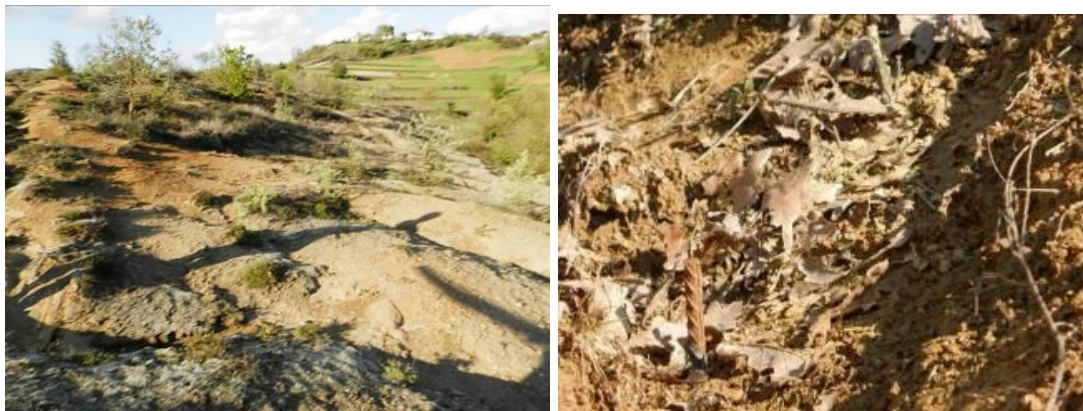
Figure 37 - Example of plot for measuring gully erosion intensity using pins
